PROPOSED REDEVELOPMENT OF BURBIDGE SITE.

Henry Thomas (Trustee)
On behalf of the Cambrian Railways Trust.

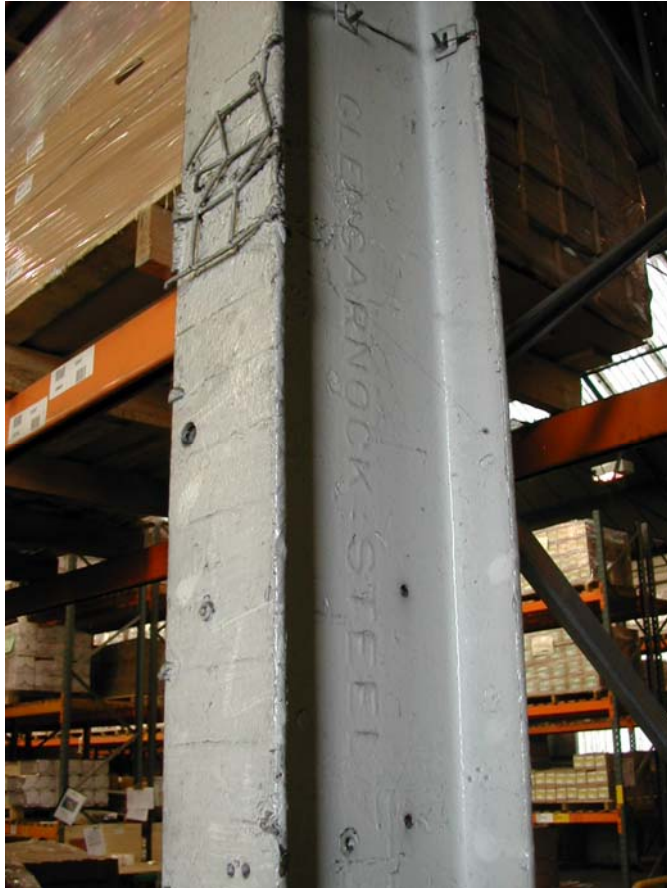
A stanchion between bays 1 and 2. The Glengarnock Steel Co. Ltd. was trading from 1890 to 1915, the works being taken over by Colvilles Ltd. then British Steel.

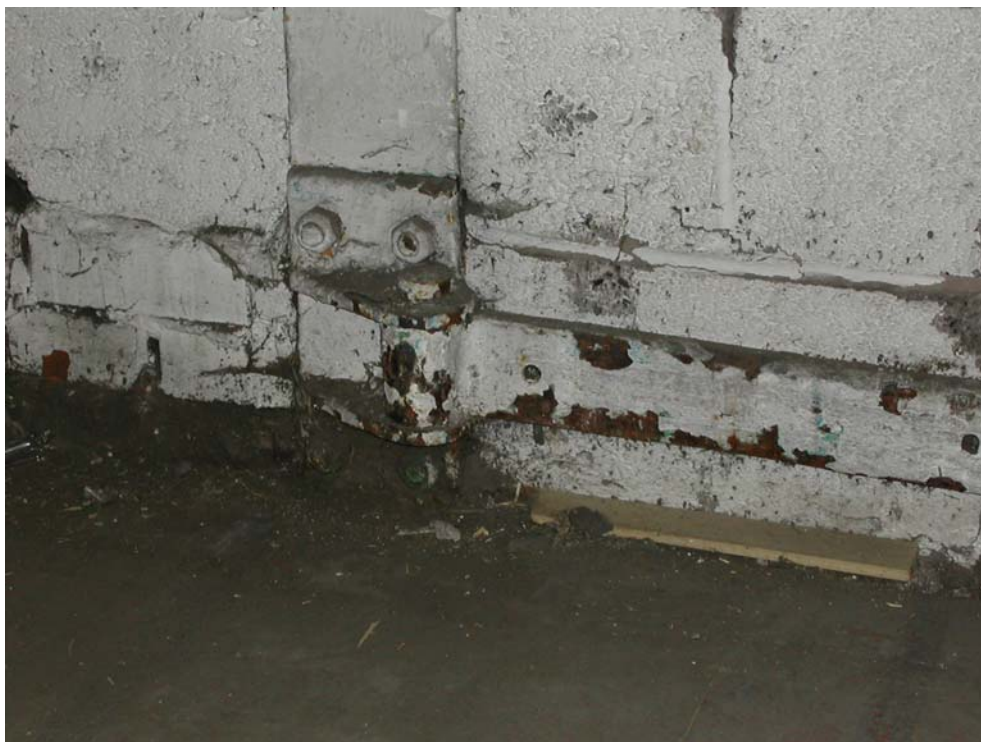
An original bottom hinge to a blocked-up door opening, bay 1.

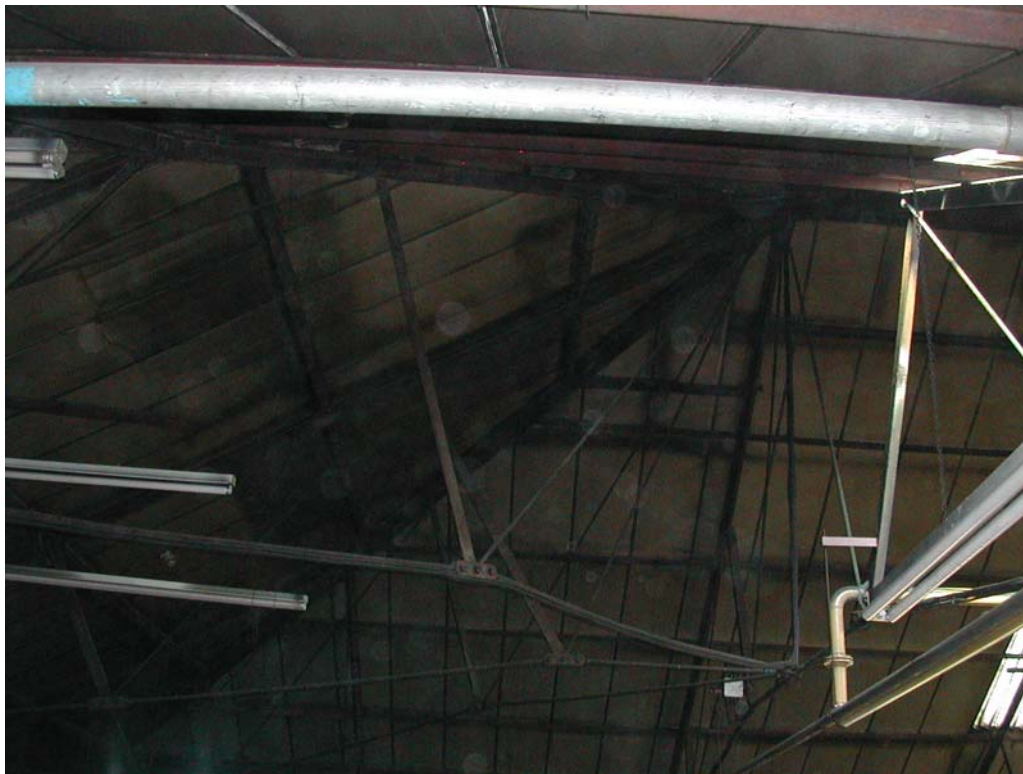
The roof and wall cladding are recent replacements, although translucent sheeting echoes the location of four of the five previous windows on the north-west elevation. The floor of course has also been replaced. However it is very misleading to state that "the historic fabric has been substantially lost" (Conservation Statement para. 5.5) because the original steel framework is virtually complete, including I-section stanchions, side sheeting angles, roof trusses, purlins, and even door hinges, – the only significant loss is where a larger doorway has been formed in the end elevation of bay 2. The trusses are lightweight assemblies using round bar for tension members and angle or T-section for compression members; they are very efficient in the use of material and elegant in appearance, especially the complex arrangement of half-trusses and braced principle rafters around the hips where bay 1 abuts the older building.

Half-trusses at hipped end of bay 1

The loss of this steelwork is clearly unacceptable in conservation terms, and would also seem economically unjustified. The buildings would lend themselves to a use

where the roof structure remains a visible feature internally, rather than a cinema – perhaps a large retail unit. The exterior should be re-clad to more-or-less reinstate its pre-1965 appearance. In order to visually read the origin of the building, the series of large door openings for rail tracks should be apparent on the north-east elevation (which is the right position for a main entrance facing the proposed car park) and the north-west elevation should have the five large windows reinstated plus small doors if needed.

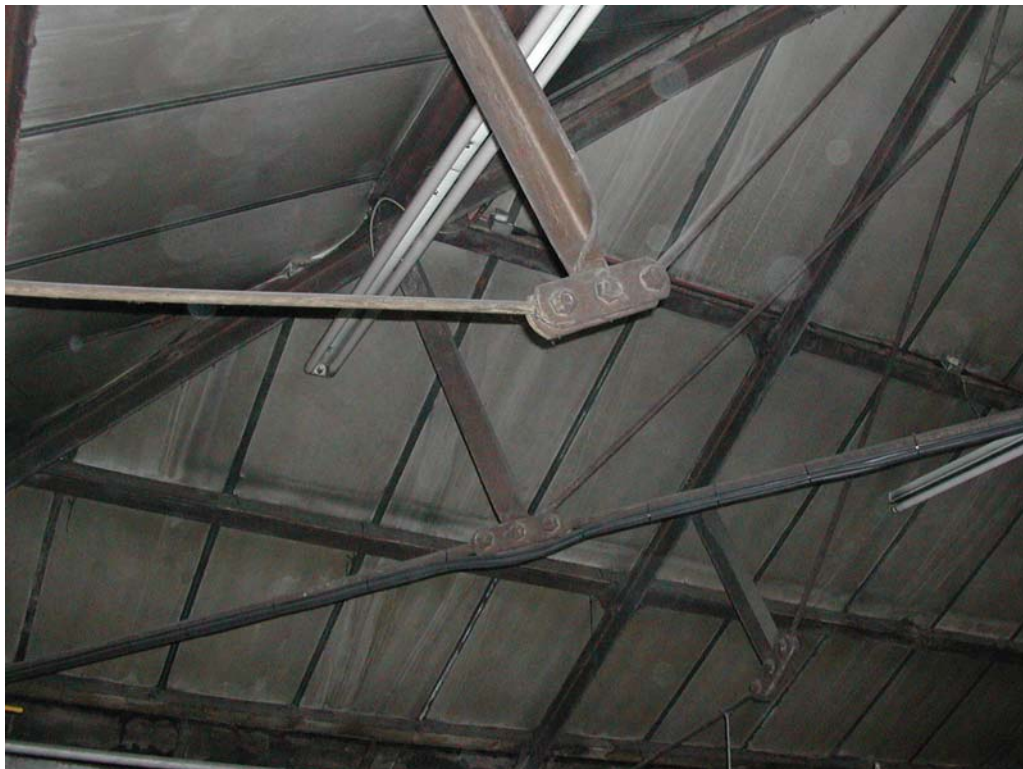
Half-truss and braced principle rafters at hipped end of bay 1.

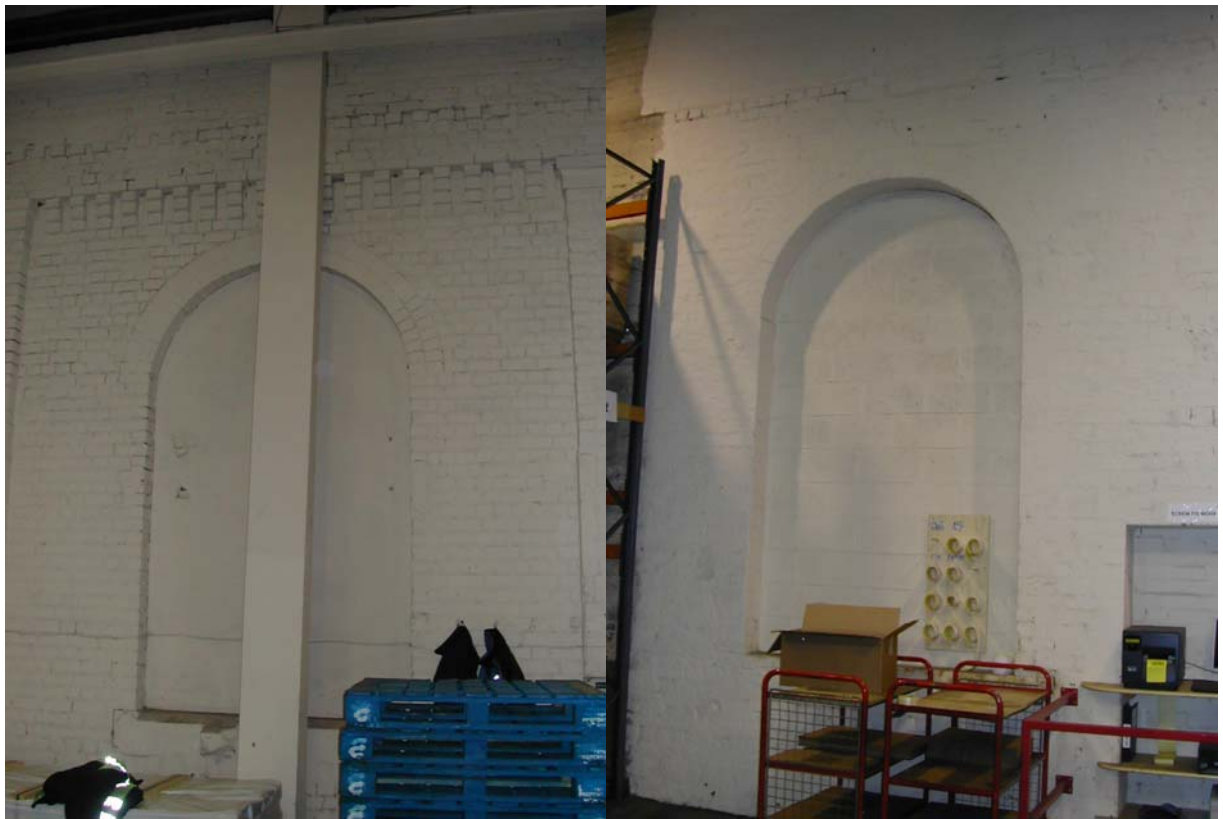
We looked at the main four-road shed, which is about 67 x 200 ft (20 x 61m.). The side walls are of 450mm thick brickwork with 560mm thick piers and decorative corbelling, and approx 12 blocked round-headed window openings each side. The south-west wall was removed when the building was re-roofed in 1939. On the north-east side brick piers remain between the lorry loading-bay openings, and a battered brick plinth can be seen; it is not yet clear what form of openings there were in this wall previously, because the railway tracks terminated inside the shed.

Loco shed window opening and eaves corbelling from outside (left) and inside (right).

We have urged the developer to retain and make use of this substantial and impressive structure, but so far to no avail.

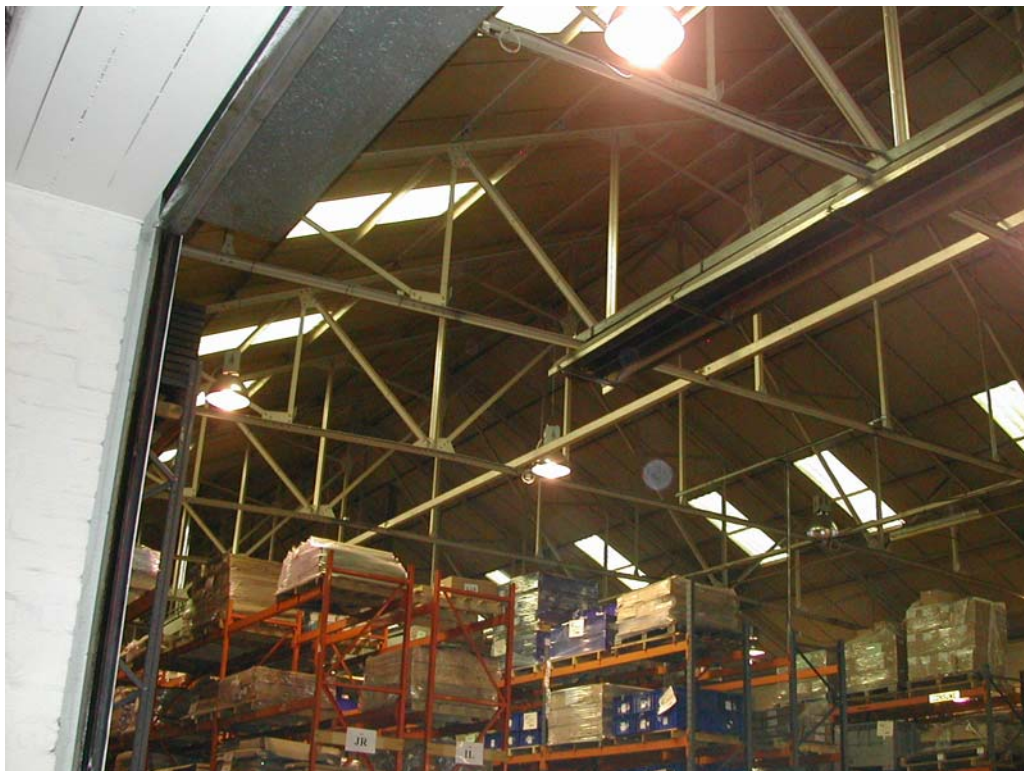
The floor has been built up to the height of lorry decks. The 1939 roof trusses are of steel angle, but the cladding is recent. I recall the large vents on the ridge still being visible in about the 1980's

1939 roof trusses of loco shed.

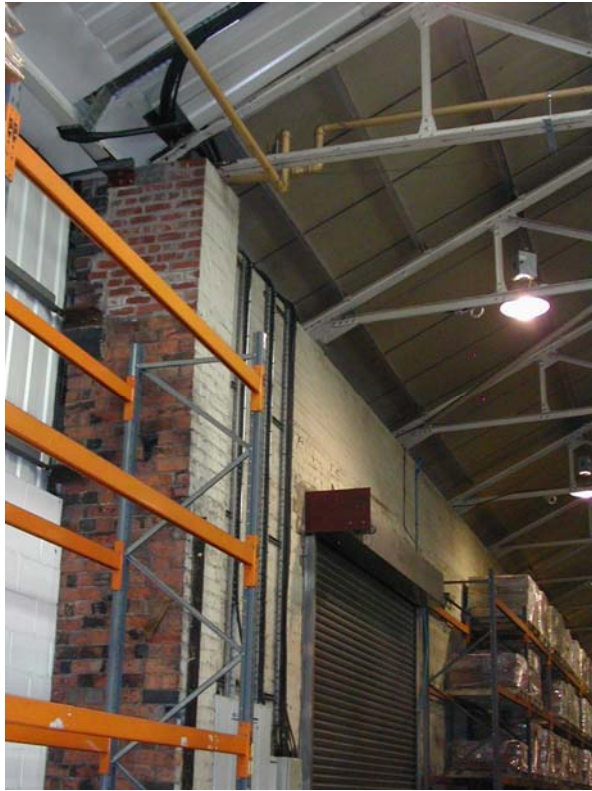
South-west end of loco shed, as altered for 1939 re-roofing (and again recently?), showing unpainted brick pier.

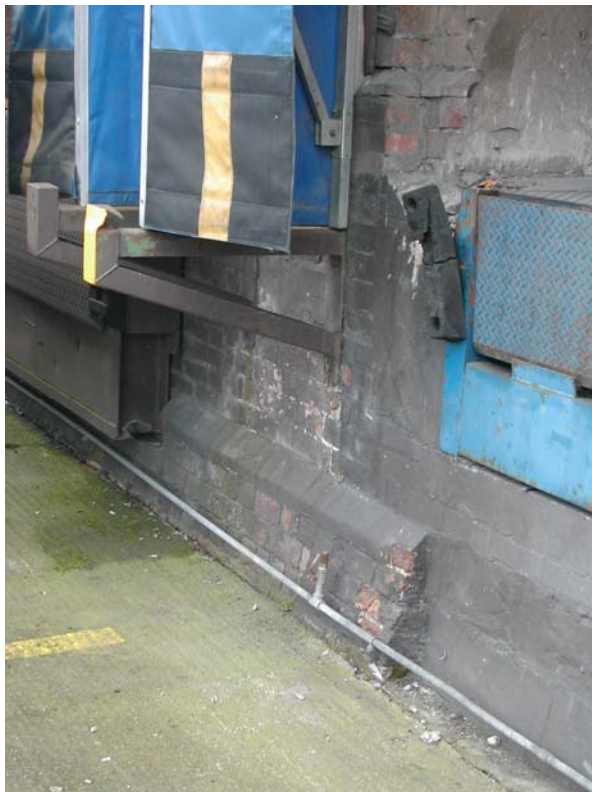
North-east end of loco shed, showing original openings adapted for lorry loading, and battered plinth.
